**Flood Control Project Maintenance
Levee Inspections**

Fall 2019 Levee Maintenance Deficiency Summary Report

Sacramento River Basin

**Flood Control Project Maintenance
Levee Inspections****LMA District Cover Sheet****Fall 2019 Levee Inspection Results****Reclamation District No. 0003 Grand Island**

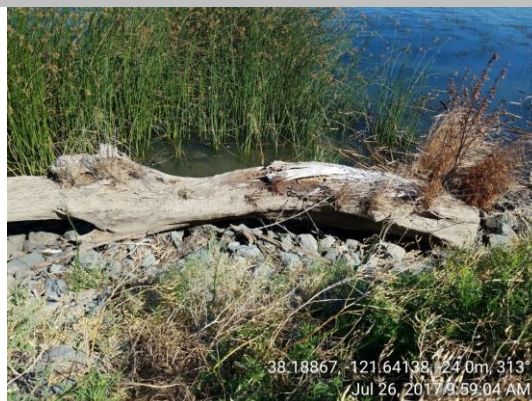
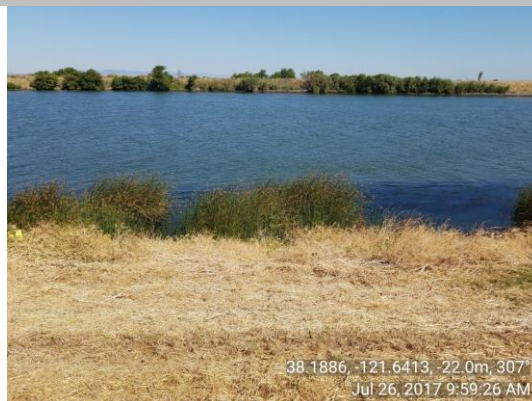
LM Start	10.15	Rating **	A/W	Issue No.	72
LM End	10.21	Issue Type +	Ma	Location *	WS
Category	Supplemental			GPS Latitude/Longitude	
				Start	End
Item	2017 Storm Damage			38.188431 °	38.187803 °
				-121.641703 °	-121.642478 °
DWR ID	LMA-103				
Comment Code					
Inspector Comment					
Levee Evaluation Comments					
Description:District station 536+35 to 539+47, Sec. 16, T. 4 N. R. 3 E., M.D.M. The waterside slope experienced sloughing and erosion along approximately 312 linear feet of Steamboat Slough (Unit 1). Sloughing commences at approximately 1/4 of the way down the slope from the crown and extends to the rip rap.					
Site ID No:277					
Site Designation:LMA-103					
Repair Type: Erosion					
Rating:Area of Concern					
Field Date:7/26/2017					
Notes:

LM Start	10.15	Rating **	A/W	Issue No.	72 (cont)	
LM End	10.21	Issue Type +	Ma	Location *	WS	
Category	Supplemental			GPS Latitude/Longitude		
				Start	End	
Item	2017 Storm Damage			38.188431 °	38.187803 °	
				-121.641703 °	-121.642478 °	
DWR ID	LMA-103					
Comment Code						
Inspector Comment						
Levee Evaluation Comments						
Description:District station 536+35 to 539+47, Sec. 16, T. 4 N. R. 3 E., M.D.M. The waterside slope experienced sloughing and erosion along approximately 312 linear feet of Steamboat Slough (Unit 1). Sloughing commences at approximately 1/4 of the way down the slope from the crown and extends to the rip rap.						
Site ID No:277						
Site Designation:LMA-103						
Repair Type: Erosion						
Rating:Area of Concern						
Field Date:7/26/2017						
Notes:

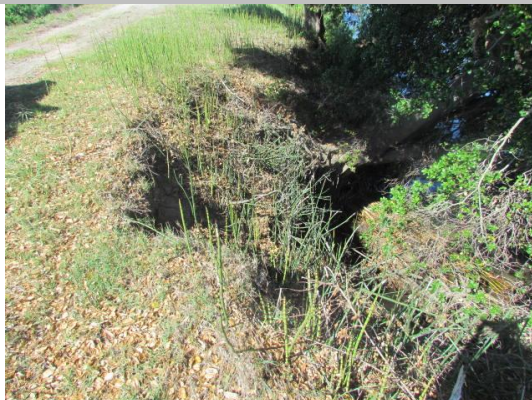
Photo 2 of 2 : FA_2019_RD0003_24_96_20190826_00079.jpg

LM Start	10.75	Rating **	A/W	Issue No.	96 (cont)
LM End	10.75	Issue Type +	Ma	Location *	WS
Category	Earthen Levee			GPS Latitude/Longitude	
				Start	End
Item	Erosion / Bank Caving			38.183422 °	38.183422 °
				-121.650182 °	-121.650182 °
DWR ID	DWR_RD0003_01_s_2013_96				
Comment Code					
E2 : Schedule repair of erosion site prior to the next inspection.					
Inspector Comment					
Levee is extra wide in this section. Erosion is occurring outside the theoretical prism.

Looking southwest at erosion on waterward slope.

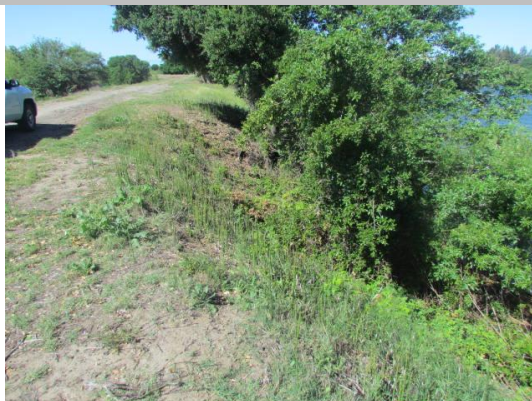
Photo 1 of 2 : FA_2019_RD0003_24_97_20190826_00080.jpg

LM Start	10.78	Rating **	A/W	Issue No.	97
LM End	10.80	Issue Type +	Ma	Location *	WS
Category	Earthen Levee			GPS Latitude/Longitude	
				Start	End
Item	Erosion / Bank Caving			38.183228 °	38.183123 °
				-121.650797 °	-121.651070 °
DWR ID	DWR_RD0003_01_s_2013_97				
Comment Code					
E2 : Schedule repair of erosion site prior to the next inspection.					
Inspector Comment					
Levee is extra wide in this section. Erosion is occurring outside the theoretical prism.

Looking south at erosion on waterward slope.

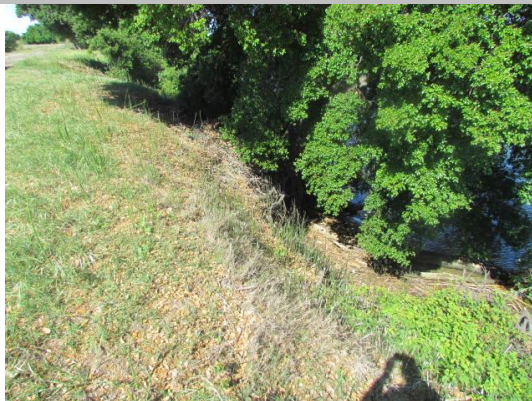
Photo 2 of 2 : FA_2019_RD0003_24_97_20190826_00081.jpg

Looking southwest at erosion on waterward slope.

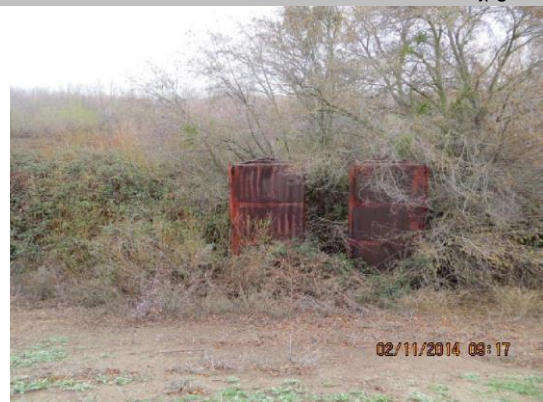
Photo 3 of 3 : UCIP_FA_2019_29165_53864.jpg

Steel weir on LS toe.

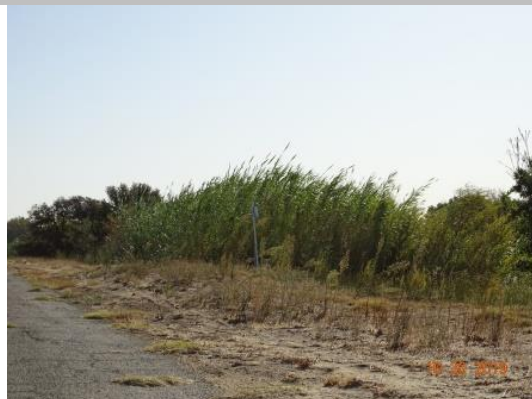
Photo 1 of 1 : FA_2019_RD0003_25_5_20191031_00355.jpg

LM Start	0.30	Rating **	U	Issue No.	5
LM End	0.32	Issue Type +	Ma	Location *	WS
Category	Earthen Levee			GPS Latitude/Longitude	
				Start	End
Item	Vegetation			38.174281°	38.174209°
				-121.648698°	-121.648352°
DWR ID	DWR_RD0003_02_s_2019_5				
Comment Code					
V2 : Remove the wild growth other than native grasses from the levee slopes.					
Inspector Comment					
Arundo on the waterside slope.

View looking upstream at arundo on the waterside slope (Fall 2019).

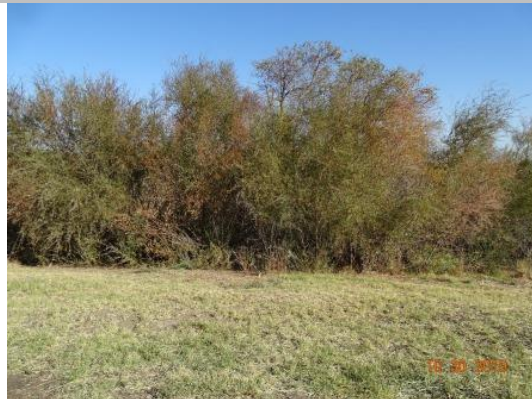
Photo 1 of 1 : FA_2019_RD0003_25_151_20191031_00352.jpg

LM Start	0.31	Rating **	U	Issue No.	151
LM End	0.35	Issue Type +	Ma	Location *	LS
Category	Earthen Levee			GPS Latitude/Longitude	
				Start	End
Item	Vegetation			38.174235 °	38.174109 °
				-121.648479 °	-121.647870 °
DWR ID	DWR_RD0003_02_s_2016_151				
Comment Code					
V2 : Remove the wild growth other than native grasses from the levee slopes.					
Inspector Comment					
Remove young willows along landside toe.

View of willows on the landside slope (Fall 2019).

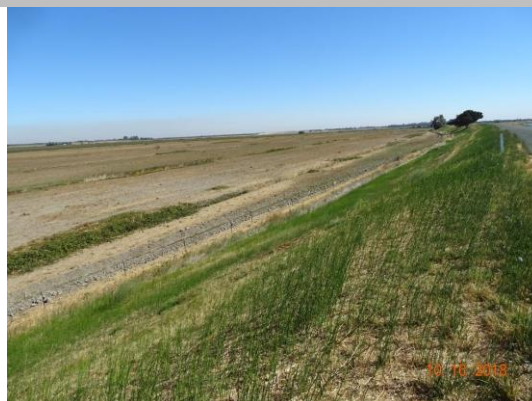
Photo 1 of 1 : FA_2019_RD0003_25_120_20190826_00089.jpg

LM Start	0.49	Rating **	M	Issue No.	120
LM End	0.84	Issue Type +	En	Location *	LS
Category	Earthen Levee			GPS Latitude/Longitude	
				Start	End
Item	Encroachments			38.173665 °	38.173525 °
				-121.645428 °	-121.639000 °
DWR ID	DWR_RD0003_02_f _ 2018_120				
Comment Code					
DT : Ditch					
Inspector Comment					
There is a ditch within 10' of the levee toe.

View looking upstream at temporary v-ditch at the edge of the landside toe (October 2018).

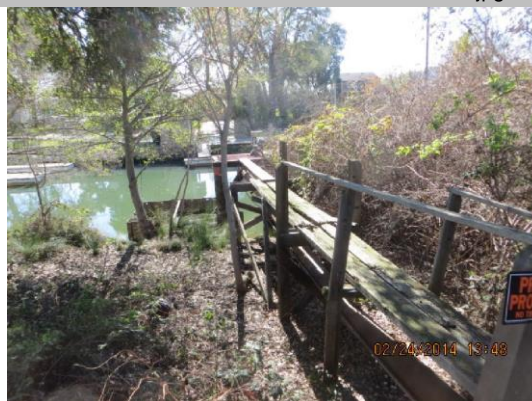
Photo 2 of 3 : UCIP_FA_2019_31083_56981.jpg

Comment Code						
Inspector Comment						
DS_ID:22209 FS_ID:31083 EP_NO: 1647 Repair Type: Non-Urgent Crossing Status: Found UCIP Comments: Sag in pavement over pipe on crown and wooden walkway to pump falling apart. Good candidate for video inspection. FIELD_STRUCT_DESC: 10-inch steel irrigation discharge pipe through the levee, invert elevation 5.8 feet below the crown. Pump on a pile structure in the channel. Service pole on the landside (LS) slope. 1.5-inch electrical conduit through the levee, 3 feet below the crown. 42-inch concrete standpipe at the LS toe. (Plans for installing a 1.5-inch electrical conduit through the levee authorized under Permit No. 1647, 1952 - Guiseppe and Emma D. Rosellini). [Additional References: DWR Levee Log, 1993. USACE Sacramento O&M Manual 104, February 1960, (RM 16.49)]. FS Date: 2/24/2014

Pump on pier on WS slope. Wooden walkway failing.

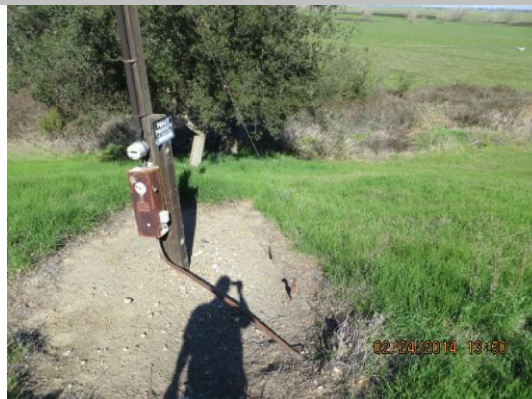
Photo 3 of 3 : UCIP_FA_2019_31083_56980.jpg

Meter on pole on LS slope.

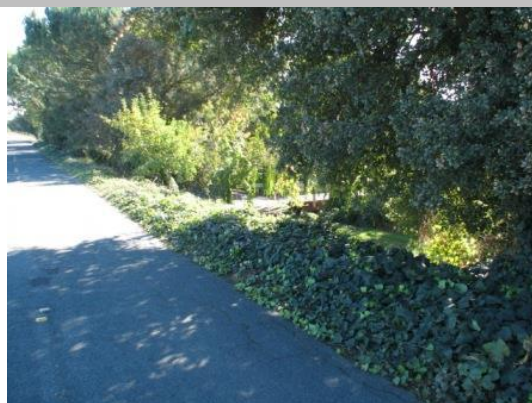
Photo 1 of 1 : FA_2019_RD0003_25_70_20190826_00046.jpg

LM Start	1.88	Rating **	U	Issue No.	70
LM End	1.93	Issue Type +	En	Location *	WS
Category	Earthen Levee			GPS Latitude/Longitude	
				Start	End
Item	Vegetation			38.166525 °	38.166176 °
				-121.622201 °	-121.621332 °
DWR ID	DWR_RD0003_02_s_2012_70				
Comment Code					
V6 : Landscaping					
Inspector Comment

Landscaping on levee slope obstructs visibility and access.

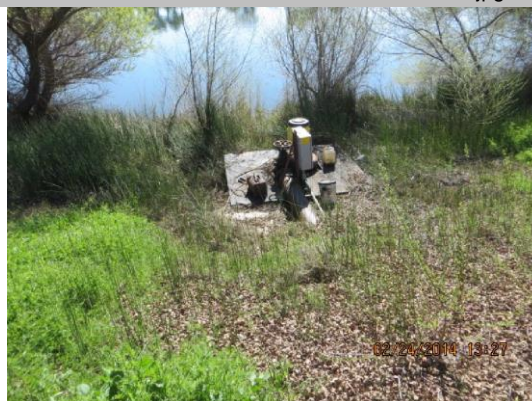
Photo 1 of 3 : UCIP_FA_2019_31026_56909.jpg

Comment Code						
Inspector Comment						
DS_ID:22211 FS_ID:31026 EP_NO: 2986 Repair Type: Non-Urgent Crossing Status: Found UCIP Comments: Trench over pipe on LS toe may indicate damage to pipe. Repair pipe and fill trench. FIELD_STRUCT_DESC: 12-inch steel irrigation discharge pipe through the levee, 5 feet below the crown. Pump and gate valve on the waterside (WS) slope. 42-inch concrete standpipe at the landside (LS) toe. 1.5-inch steel electrical conduit through the levee at the same location. (Plans for installation of a pumping plant on the levee authorized under Permit No. 2986, 1959 - Ike Craven). [Additional Reference(s): DWR Levee Log, 1993. USACE Sacramento O&M Manual 104, February 1960, (RM 17.25), referenced as invert elevation 4 feet below the crown]. FS Date: 2/24/2014

Pump, pipe, gate valve, and electrical conduit visible on WS slope.

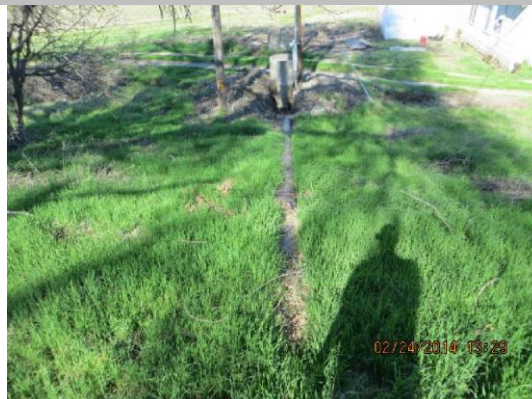
Photo 2 of 3 : UCIP_FA_2019_31026_56908.jpg

Pipe, meter, power pole, and concrete standpipe visible on LS slope/toe.

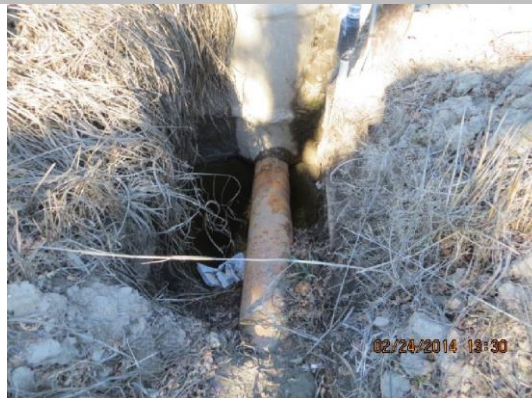
Photo 3 of 3 : UCIP_FA_2019_31026_56907.jpg

Comment Code						
Inspector Comment						
DS_ID:22211 FS_ID:31026 EP_NO: 2986 Repair Type: Non-Urgent Crossing Status: Found UCIP Comments: Trench over pipe on LS toe may indicate damage to pipe. Repair pipe and fill trench. FIELD_STRUCT_DESC: 12-inch steel irrigation discharge pipe through the levee, 5 feet below the crown. Pump and gate valve on the waterside (WS) slope. 42-inch concrete standpipe at the landside (LS) toe. 1.5-inch steel electrical conduit through the levee at the same location. (Plans for installation of a pumping plant on the levee authorized under Permit No. 2986, 1959 - Ike Craven). [Additional Reference(s): DWR Levee Log, 1993. USACE Sacramento O&M Manual 104, February 1960, (RM 17.25), referenced as invert elevation 4 feet below the crown]. FS Date: 2/24/2014

Trench excavated over pipe at Standpipe/LS toe.

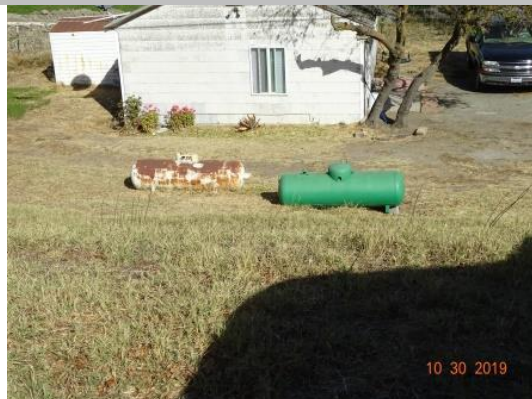
Photo 1 of 1 : FA_2019_RD0003_25_221_20191031_00354.jpg

LM Start	2.40	Rating **	M	Issue No.	221
LM End	2.40	Issue Type +	En	Location *	LS
Category	Earthen Levee			GPS Latitude/Longitude	
				Start	End
Item	Encroachments			38.164393 °	38.164393 °
				-121.613183 °	-121.613183 °
DWR ID	DWR_RD0003_02_f_2019_221				
Comment Code					
TA : Tank					
Inspector Comment					
Two propane tanks are on the landside slope.

View of tanks on the landside slope (Fall 2019).

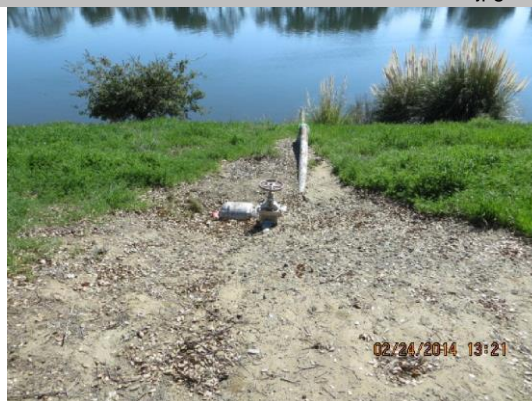
Photo 1 of 3 : UCIP_FA_2019_31025_56906.jpg

Comment Code					
Inspector Comment					
DS_ID:22212 FS_ID:31025 EP_NO: 1289 Repair Type: Non-Urgent Crossing Status: Indicator Found UCIP Comments: Appears abandoned and if so should be done so properly. FIELD_STRUCT_DESC: *ABANDONED* 6-inch steel irrigation discharge pipe through the levee, invert elevation 4.5 feet below the crown. Pump and gate valve on the waterside (WS) slope. Service pole on the landside (LS) with a 1.5-inch electrical conduit through the levee at the same location. (Plans for installing an irrigation pumping plant and a 6-inch steel pipe through the levee authorized under Permit No. 1289, 1948 - Carlos Silva). [Additional Reference(s): DWR Levee Log, 1993. USACE Sacramento O&M Manual 104, February 1960, (RM 17.56)]. FS Date: 2/24/2014

Pipe, pump, and gate valve on WS slope.

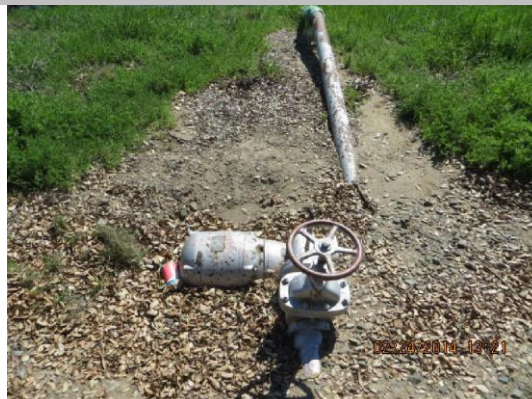
Photo 2 of 3 : UCIP_FA_2019_31025_56905.jpg

Pump and gate valve on WS slope.

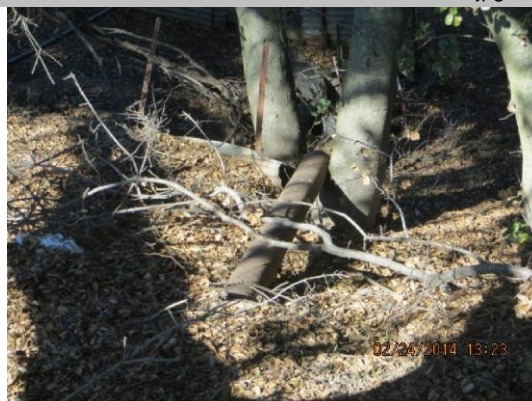
Photo 3 of 3 : UCIP_FA_2019_31025_56904.jpg

Comment Code						
Inspector Comment						
DS_ID:22212 FS_ID:31025 EP_NO: 1289 Repair Type: Non-Urgent Crossing Status: Indicator Found UCIP Comments: Appears abandoned and if so should be done so properly. FIELD_STRUCT_DESC: *ABANDONED* 6-inch steel irrigation discharge pipe through the levee, invert elevation 4.5 feet below the crown. Pump and gate valve on the waterside (WS) slope. Service pole on the landside (LS) with a 1.5-inch electrical conduit through the levee at the same location. (Plans for installing an irrigation pumping plant and a 6-inch steel pipe through the levee authorized under Permit No. 1289, 1948 - Carlos Silva). [Additional Reference(s): DWR Levee Log, 1993. USACE Sacramento O&M Manual 104, February 1960, (RM 17.56)]. FS Date: 2/24/2014

Pipe on LS slope.

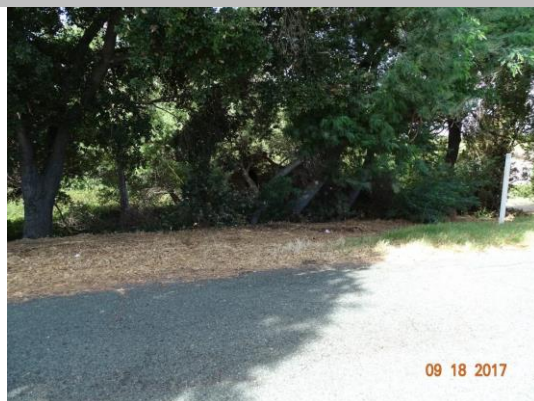
Photo 1 of 2 : FA_2019_RD0003_25_7_20190826_00006.jpg

Looking northwest at the landside slope.

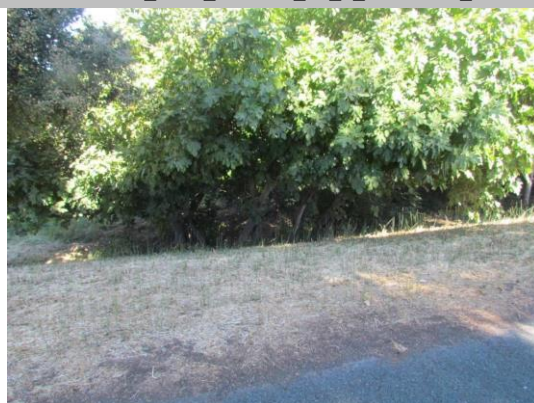
Photo 2 of 2 : FA_2019_RD0003_25_7_20190826_00007.jpg

Looking north at fig tree at landward toe.

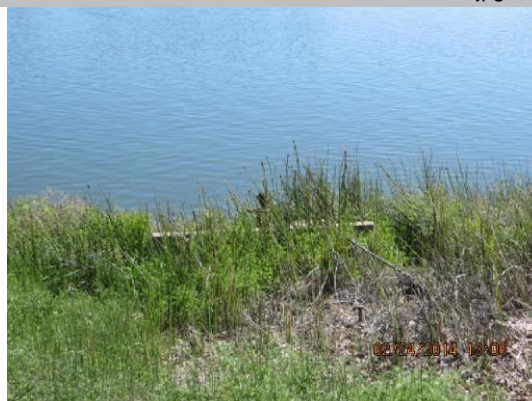
Photo 1 of 3 : UCIP_FA_2019_30983_56877.jpg

LM Start	3.30	Rating **	M	Issue No.	958	
LM End	3.30	Issue Type +	En	Location *		
Category	Supplemental			GPS Latitude/Longitude		
				Start	End	
Item	DRAFT DWR UCIP Field Study			38.168754 °	38.168754 °	
				-121.598196 °	-121.598196 °	
DWR ID	22217					
Comment Code						
Inspector Comment						
DS_ID:22217 FS_ID:30983 EP_NO: N/A Repair Type: Non-Urgent Crossing Status: Found UCIP Comments: Pipe appears abandoned and if so should be done so properly. FIELD_STRUCT_DESC: 6-inch steel irrigation discharge pipe through the levee, invert elevation 3.5 feet below the crown. Pump and gate valve on a concrete pad on the waterside (WS) slope. Meter pole at the landside (LS) toe with a 1.5-inch electrical conduit through the levee at the same location. (Lillie). [Additional Reference(s): DWR Levee Log, 1993. USACE Sacramento O&M Manual 104, February 1960, (RM 18.17)]. FS Date: 2/24/2014

Pump on concrete platform on WS slope.

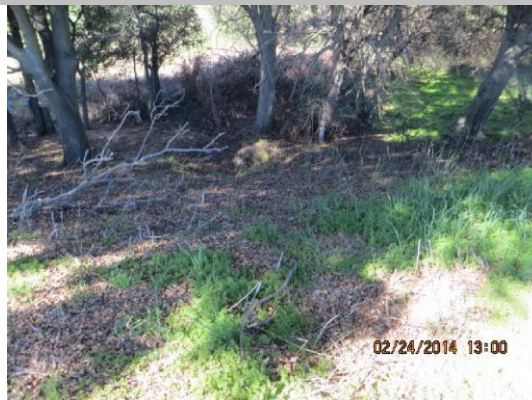
Photo 2 of 3 : UCIP_FA_2019_30983_56876.jpg

Pipe visible at LS toe.

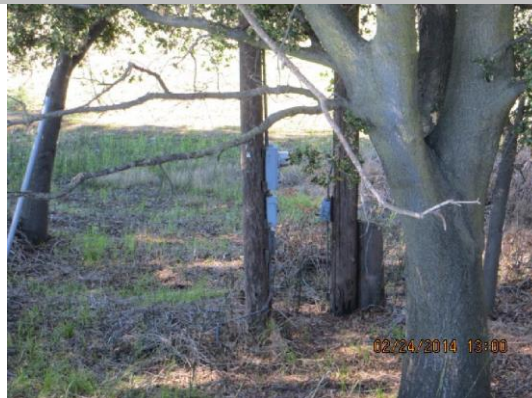
Photo 3 of 3 : UCIP_FA_2019_30983_56875.jpg

Comment Code						
Inspector Comment						
DS_ID:22217 FS_ID:30983 EP_NO: N/A Repair Type: Non-Urgent Crossing Status: Found UCIP Comments: Pipe appears abandoned and if so should be done so properly. FIELD_STRUCT_DESC: 6-inch steel irrigation discharge pipe through the levee, invert elevation 3.5 feet below the crown. Pump and gate valve on a concrete pad on the waterside (WS) slope. Meter pole at the landside (LS) toe with a 1.5-inch electrical conduit through the levee at the same location. (Lillie). [Additional Reference(s): DWR Levee Log, 1993. USACE Sacramento O&M Manual 104, February 1960, (RM 18.17)]. FS Date: 2/24/2014

Meter on powerpole on LS toe.

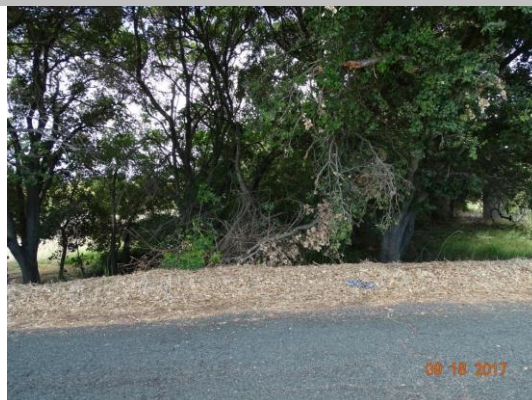
Photo 1 of 1 : FA_2019_RD0003_25_154_20190826_00139.jpg

LM Start	3.30	Rating **	M	Issue No.	154
LM End	3.30	Issue Type +	Ma	Location *	LS
Category	Earthen Levee			GPS Latitude/Longitude	
				Start	End
Item	Encroachments			38.168750 °	38.168750 °
				-121.598152 °	-121.598152 °
DWR ID	DWR_RD0003_02_f_2017_154				
Comment Code					
TR : Tree or limb					
Inspector Comment					
There is a downed tree on the landside slope.

Looking northwest at the landside slope.

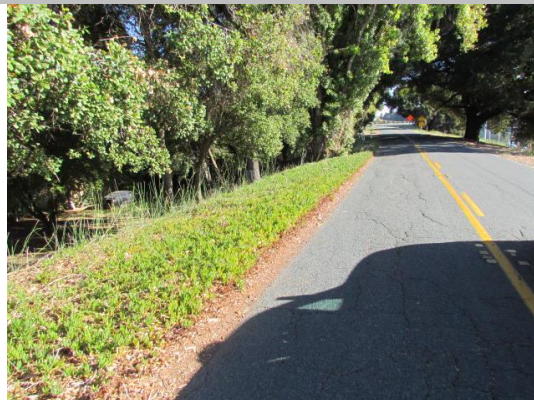
Photo 1 of 1 : FA_2019_RD0003_25_46_20190826_00033.jpg

LM Start	3.33	Rating **	M	Issue No.	46
LM End	3.33	Issue Type +	En	Location *	LS
Category	Earthen Levee			GPS Latitude/Longitude	
				Start	End
Item	Vegetation			38.169061 °	38.169061 °
				-121.597765 °	-121.597765 °
DWR ID	DWR_RD0003_02_s_2012_46				
Comment Code					
V6 : Landscaping					
Inspector Comment					
Iceplant and trees are blocking the view of the landside slope.

Looking northeast at landscaping blocking view of landward slope.

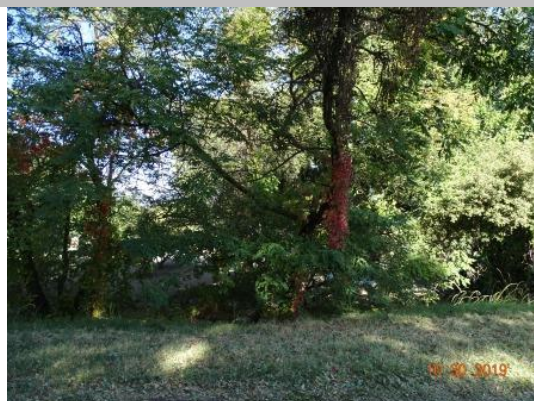
Photo 1 of 1 : FA_2019_RD0003_25_179_20191031_00353.jpg

LM Start	3.40	Rating **	M	Issue No.	179
LM End	3.40	Issue Type +	Ma	Location *	LS
Category	Earthen Levee			GPS Latitude/Longitude	
				Start	End
Item	Encroachments			38.169861 °	38.169861 °
				-121.596926 °	-121.596926 °
DWR ID	DWR_RD0003_02_s_2018_179				
Comment Code					
TR : Tree or limb					
Inspector Comment					
Fallen tree on the landside slope.

View of fallen tree on the landside slope (Fall 2019).

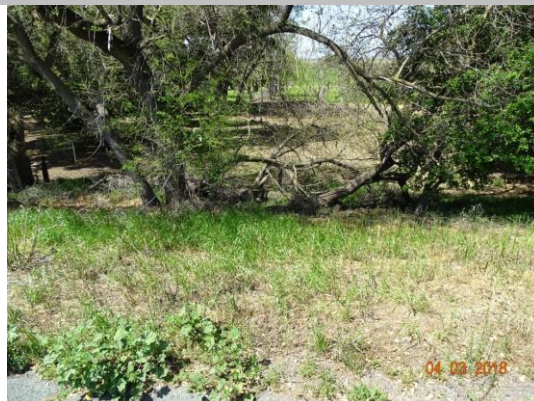
Photo 1 of 1 : FA_2019_RD0003_25_180_20190826_00156.jpg

LM Start	3.44	Rating **	M	Issue No.	180
LM End	3.44	Issue Type +	Ma	Location *	LS
Category	Earthen Levee			GPS Latitude/Longitude	
				Start	End
Item	Encroachments			38.170293 °	38.170293 °
				-121.596497 °	-121.596497 °
DWR ID	DWR_RD0003_02_s_2018_180				
Comment Code					
TR : Tree or limb					
Inspector Comment					
Fallen tree at landside toe blocks access.

Fallen tree at landside toe should be removed.

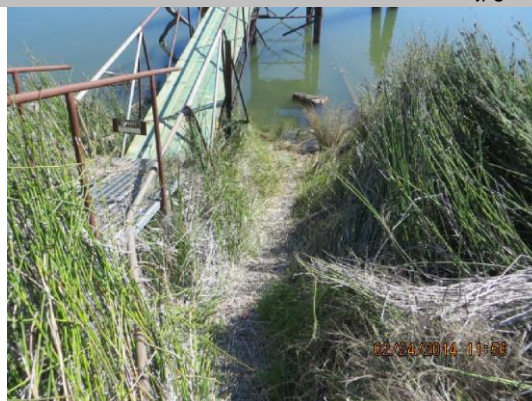
Photo 2 of 3 : UCIP_FA_2019_30963_56861.jpg

Comment Code						
Inspector Comment						
DS_ID:22221 FS_ID:30963 EP_NO: 1283 Repair Type: Non-Urgent Crossing Status: Indicator Found UCIP Comments: Permit for 12-inch pipe and pump on pier. Unable to identify permit for 6-inch pipe. FIELD_STRUCT_DESC: 12-inch steel irrigation discharge pipe through the levee, invert elevation 6 feet below the crown. Pump, shutoff valve, power pole, and vent at the landside (LS) toe. 6-inch steel pipe appears to be sleeved through the 12-inch pipe. 1.5-inch steel electrical conduit at the same location. (Plans for installing a pumping plant and a 12-inch pipe through the levee authorized under Permit No. 1283, 1948 - Manuel E. and Frank E. Silva). [Additional Reference(s): DWR Levee Log, 1993. USACE Sacramento O&M Manual 104, February 1960, (RM 18.66)]. FS Date: 2/24/2014

Pipe visible to right of walkway on LS slope and in water.

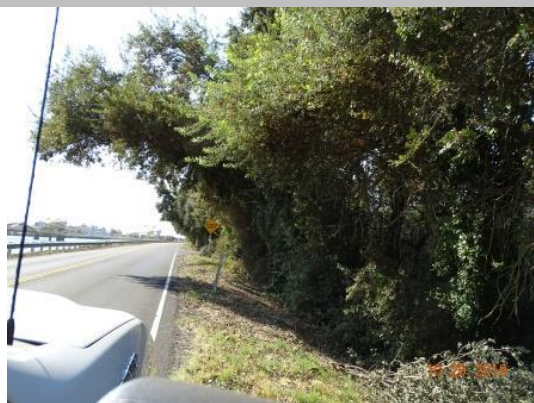
Photo 1 of 1 : FA_2019_RD0003_25_953_20191030_00350.jpg

LM Start	3.77	Rating **	U	Issue No.	953
LM End	3.87	Issue Type +	En	Location *	LS
Category	Earthen Levee			GPS Latitude/Longitude	
				Start	End
Item	Vegetation			38.174497°	38.175675°
				-121.593392°	-121.592595°
DWR ID	DWR_RD0003_02_s_2012_953				
Comment Code					
V6 : Landscaping					
Inspector Comment

View looking downstream at landscaping on the landside toe (Fall 2019).

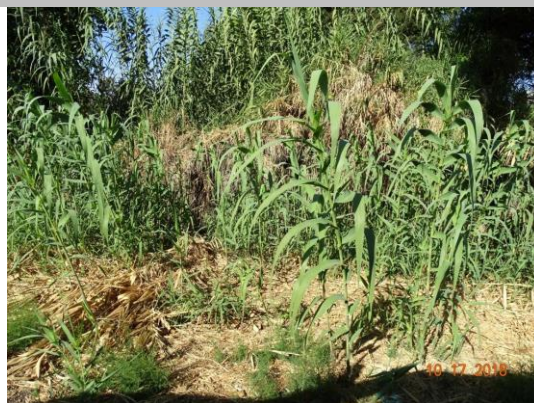
Photo 1 of 1 : FA_2019_RD0003_25_200_20190826_00166.jpg

LM Start	3.78	Rating **	U	Issue No.	200
LM End	3.78	Issue Type +	Ma	Location *	LS
Category	Earthen Levee			GPS Latitude/Longitude	
				Start	End
Item	Vegetation			38.174550 °	38.174550 °
				-121.593345 °	-121.593345 °
DWR ID	DWR_RD0003_02_f_2018_200				
Comment Code					
V2 : Remove the wild growth other than native grasses from the levee slopes.					
Inspector Comment					
Remove the arundo growth.

View of arundo growth on the landside slope (October 2018).

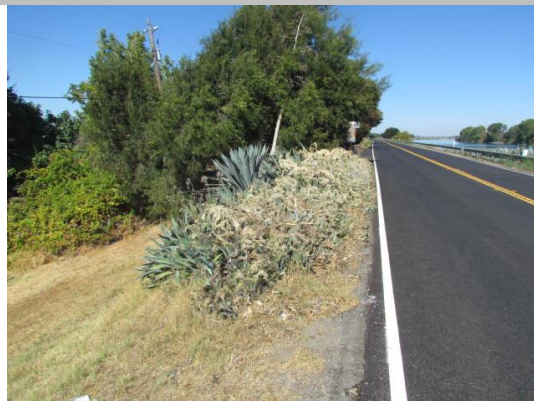
Photo 1 of 1 : FA_2019_RD0003_25_143_20190826_00121.jpg

LM Start	4.11	Rating **	M	Issue No.	143
LM End	4.11	Issue Type +	En	Location *	LS
Category	Earthen Levee			GPS Latitude/Longitude	
				Start	End
Item	Vegetation			38.178782 °	38.178782 °
				-121.590418 °	-121.590418 °
DWR ID	DWR_RD0003_02_f_2015_143				
Comment Code					
V6 : Landscaping					
Inspector Comment					
There are large century plants on the landside shoulder and slope.

Looking north at century plants on landward shoulder and slope.

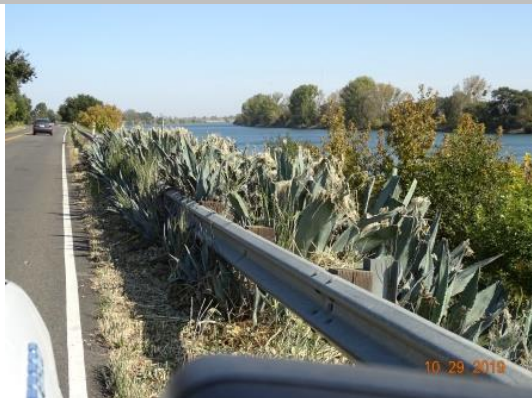
Photo 1 of 1 : FA_2019_RD0003_25_220_20191030_00351.jpg

LM Start	4.11	Rating **	M	Issue No.	220
LM End	4.11	Issue Type +	Ma	Location *	WS
Category	Earthen Levee			GPS Latitude/Longitude	
				Start	End
Item	Vegetation			38.178830 °	38.178830 °
				-121.590380 °	-121.590380 °
DWR ID	DWR_RD0003_02_f_2019_220				
Comment Code					
V2 : Remove the wild growth other than native grasses from the levee slopes.					
Inspector Comment					
There are century plants on waterside shoulder.

View looking upstream at century plants on the waterside shoulder (Fall 2019).

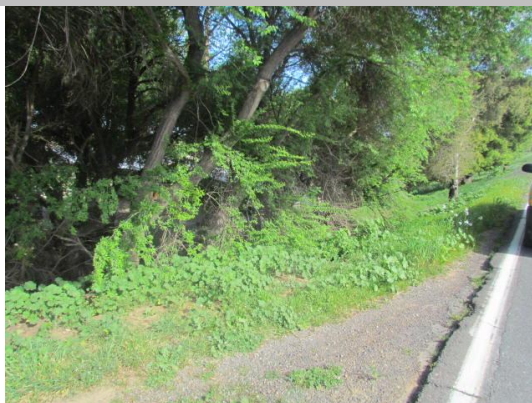
Photo 1 of 1 : FA_2019_RD0003_25_48_20190826_00034.jpg

LM Start	4.14	Rating **	A/W	Issue No.	48
LM End	4.14	Issue Type +	En	Location *	LS
Category	Earthen Levee			GPS Latitude/Longitude	
				Start	End
Item	Vegetation			38.179160 °	38.179160 °
				-121.590247 °	-121.590247 °
DWR ID	DWR_RD0003_02_f_2018_48				
Comment Code					
V6 : Landscaping					
Inspector Comment

Looking southwest at dense trees on landward slope.

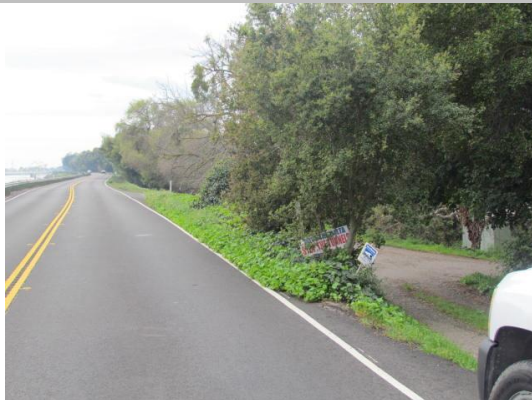
Photo 1 of 2 : FA_2019_RD0003_25_92_20190826_00070.jpg

LM Start	4.25	Rating **	U	Issue No.	92
LM End	4.33	Issue Type +	En	Location *	LS
Category	Earthen Levee			GPS Latitude/Longitude	
				Start	End
Item	Vegetation			38.180483 °	38.181540 °
				-121.589119 °	-121.588348 °
DWR ID	DWR_RD0003_02_s_2012_92				
Comment Code					
V6 : Landscaping					
Inspector Comment					
Ground cover, palm tree and other vegetation blocking view of landside slope and toe.

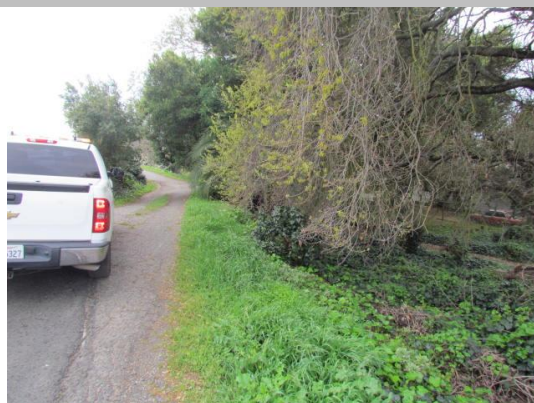
Photo 2 of 2 : FA_2019_RD0003_25_92_20190826_00071.jpg

LM Start	4.25	Rating **	U	Issue No.	92 (cont)
LM End	4.33	Issue Type +	En	Location *	LS
Category	Earthen Levee			GPS Latitude/Longitude	
				Start	End
Item	Vegetation			38.180483 °	38.181540 °
				-121.589119 °	-121.588348 °
DWR ID	DWR_RD0003_02_s_2012_92				
Comment Code					
V6 : Landscaping					
Inspector Comment					
Ground cover, palm tree and other vegetation blocking view of landside slope and toe.

Looking south at groundcover and other vegetation on landward slope.

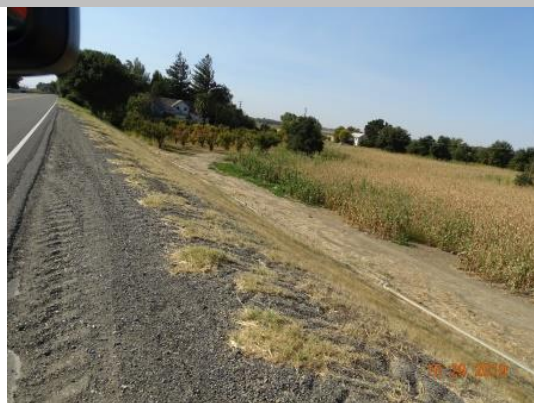
Photo 1 of 1 : FA_2019_RD0003_25_219_20191030_00349.jpg

LM Start	4.37	Rating **	M	Issue No.	219
LM End	4.37	Issue Type +	En	Location *	LS
Category	Earthen Levee			GPS Latitude/Longitude	
				Start	End
Item	Encroachments			38.182042 °	38.182042 °
				-121.587902 °	-121.587902 °
DWR ID	DWR_RD0003_02_f_2019_219				
Comment Code					
MA : Material					
Inspector Comment					
There are pipes at the landside toe.

View looking downstream at uninstalled pipes at landside toe (Fall 2019).

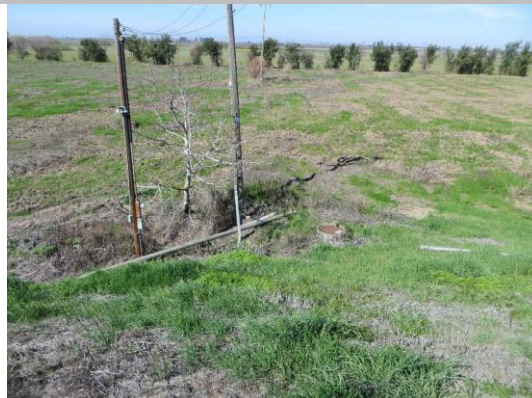
Photo 1 of 3 : UCIP_FA_2019_53484_56825.jpg

DS_ID:22224
FS_ID:53484
EP_NO: N/A
Repair Type: Non-Urgent
Crossing Status: Found
UCIP Comments: 07/20/2018 Everything appears to be the same as last time. Up and over pipe: low flood risk during high water. No integrity issues. Crossing downgraded to "Non-Urgent" because of the conditions listed above. (A. McDonald - DWR UCIP)07/06/2016 Same as last inspection. Open pipe on WS may be partially plugged. Unclear whether open pipe beneath pump platform connects to pump and crossing that rest above platform or if they are two separate crossings. If they are connected, positive closure device on pump may prevent backflow. Appears abandoned. (DWR UCIP - K. Fazel)02/24/2014 Pipe open on WS toe-visible under pump at WS toe. Pipe abandoned and should be done so properly. (DWR UCIP - G. Wylie)
FIELD_STRUCT_DESC: *ABANDONED* 6-inch steel irrigation discharge pipe through the levee, 5.4 feet below the crown. Pipe visible beneath a pump platform on the waterside (WS). Another larger steel pipe (DSID 22223) visible through the WS slope and connected to a centrifugal pump with a closure valve resting over a platform on the WS. 2-inch electrical conduit through the levee at the same location leads to service pole on the landside (LS). [Additional Reference(s): DWR Levee Log, 1993. USACE Sacramento O&M Manual 104, February 1960 (RM 19.39)]. Levee Log mentions the 6-inch pipe is plugged and cut off.

Approximate location of pipe on LS toe.

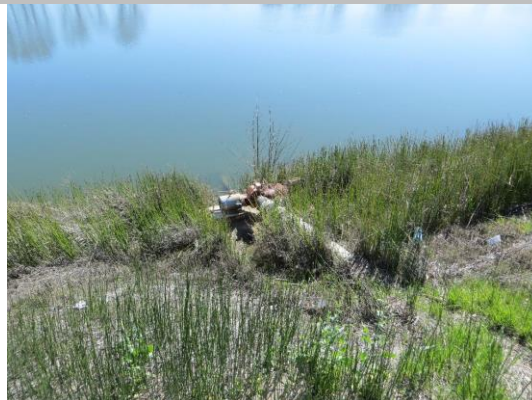
Photo 2 of 3 : UCIP_FA_2019_53484_56824.jpg

Pipe visible under pump on WS slope.

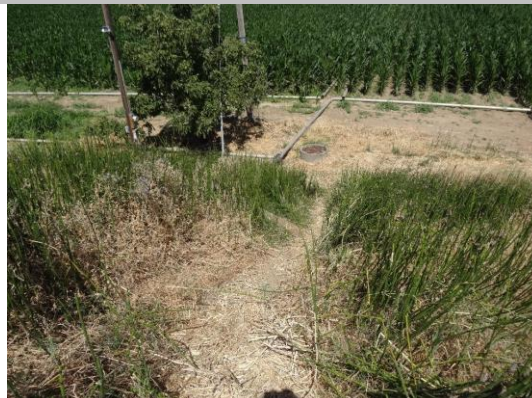
Photo 3 of 3 : UCIP_FA_2019_53484_75547.jpg

Comment Code						
Inspector Comment						
DS_ID:22224 FS_ID:53484 EP_NO: N/A Repair Type: Non-Urgent Crossing Status: Found UCIP Comments: 07/20/2018 Everything appears to be the same as last time. Up and over pipe: low flood risk during high water. No integrity issues. Crossing downgraded to "Non-Urgent" because of the conditions listed above. (A. McDonald - DWR UCIP)07/06/2016 Same as last inspection. Open pipe on WS may be partially plugged. Unclear whether open pipe beneath pump platform connects to pump and crossing that rest above platform or if they are two separate crossings. If they are connected, positive closure device on pump may prevent backflow. Appears abandoned. (DWR UCIP - K. Fazel)02/24/2014 Pipe open on WS toe-visible under pump at WS toe. Pipe abandoned and should be done so properly. (DWR UCIP - G. Wylie) FIELD_STRUCT_DESC: *ABANDONED* 6-inch steel irrigation discharge pipe through the levee, 5.4 feet below the crown. Pipe visible beneath a pump platform on the waterside (WS). Another larger steel pipe (DSID 22223) visible through the WS slope and connected to a centrifugal pump with a closure valve resting over a platform on the WS. 2-inch electrical conduit through the levee at the same location leads to service pole on the landside (LS). [Additional Reference(s): DWR Levee Log, 1993. USACE Sacramento O&M Manual 104, February 1960 (RM 19.39)]. Levee Log mentions the 6-inch pipe is plugged and cut off. FS Date: 7/20/2018

LS view; standpipe and power pole off LS toe.

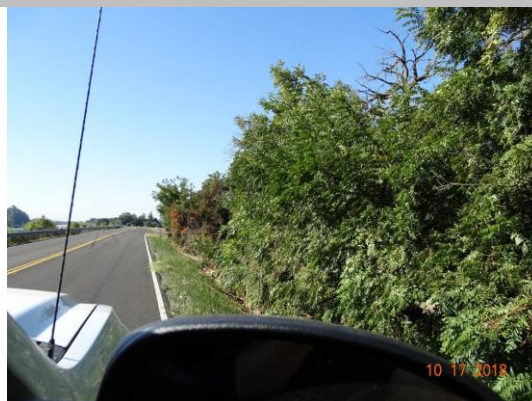
Photo 1 of 1 : FA_2019_RD0003_25_199_20190826_00165.jpg

LM Start	4.63	Rating **	U	Issue No.	199
LM End	4.66	Issue Type +	En	Location *	LS
Category	Earthen Levee			GPS Latitude/Longitude	
				Start	End
Item	Vegetation			38.185122°	38.185430°
				-121.585165°	-121.584835°
DWR ID	DWR_RD0003_02_f_2018_199				
Comment Code					
V6 : Landscaping					
Inspector Comment

View looking downstream at landscaping on the landside slope (October 2018).

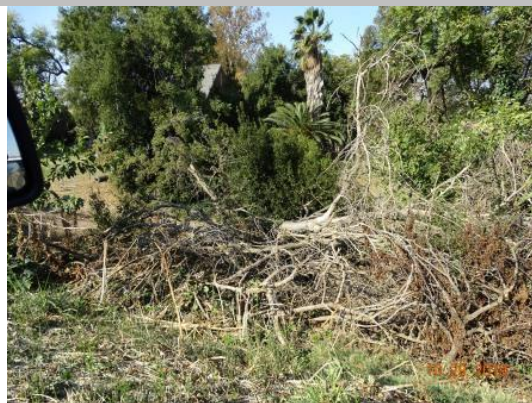
Photo 1 of 1 : FA_2019_RD0003_25_97_20191030_00348.jpg

LM Start	4.65	Rating **	U	Issue No.	97
LM End	4.65	Issue Type +	Ma	Location *	LS
Category	Earthen Levee			GPS Latitude/Longitude	
				Start	End
Item	Encroachments			38.185317 °	38.185317 °
				-121.584870 °	-121.584870 °
DWR ID	DWR_RD0003_02_s_2017_97				
Comment Code					
TR : Tree or limb					
Inspector Comment					
Fallen tree on the landside slope.

View of fallen tree on landside slope (Fall 2019).

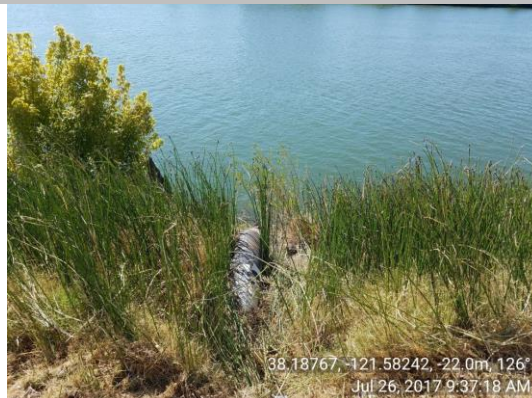
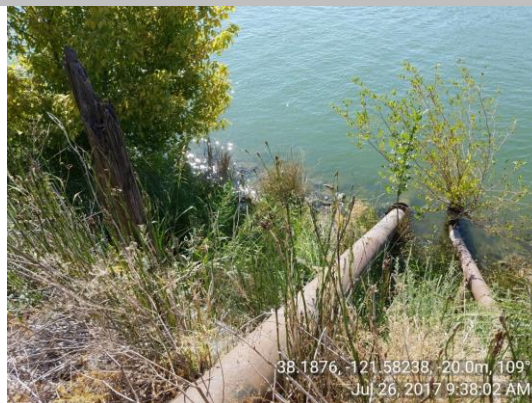
LM Start	4.86	Rating **	A/W	Issue No.	127
LM End	4.87	Issue Type +	Ma	Location *	WS
Category	Supplemental			GPS Latitude/Longitude	
				Start	End
Item	2017 Storm Damage			38.187528 °	38.187781 °
				-121.582394 °	-121.582331 °
DWR ID	LMA-104

LM Start	4.86	Rating **	A/W	Issue No.	127 (cont)
LM End	4.87	Issue Type +	Ma	Location *	WS

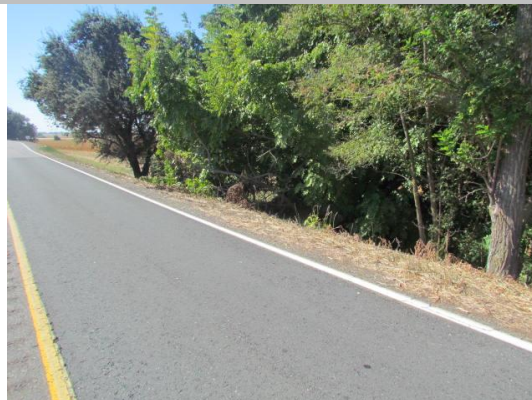
Photo 2 of 2 : FA_2019_RD0003_25_14_20190826_00016.jpg

LM Start	4.94	Rating **	M	Issue No.	14 (cont)	
LM End	4.95	Issue Type +	Ma	Location *	LS	
Category	Earthen Levee			GPS Latitude/Longitude		
				Start	End	
Item	Trim / Thin Trees			38.188344 °	38.188493 °	
				-121.581414 °	-121.581260 °	
DWR ID	DWR_RD0003_02_s_2012_14					
Comment Code						
T1 : Trim trees to at least five feet above ground level.						
Inspector Comment						
There are untrimmed trees on the landside slope and toe.

Looking southwest at untrimmed trees on landward toe. (Spring 2016)

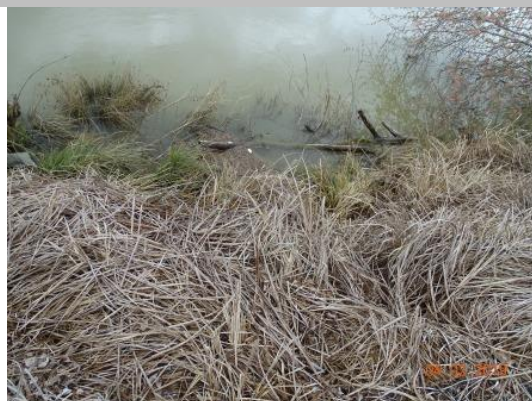
Photo 1 of 1 : FA_2019_RD0003_25_194_20190826_00016.jpg

LM Start	4.94	Rating **	A/W	Issue No.	194
LM End	4.94	Issue Type +	Ma	Location *	WS
Category	Earthen Levee			GPS Latitude/Longitude	
				Start	End
Item	Erosion / Bank Caving			38.188248 °	38.188248 °
				-121.581225 °	-121.581225 °
DWR ID	DWR_RD0003_02_s_2019_194				
Comment Code					
E1 : Note and monitor erosion site.					
Inspector Comment					
Small amount of bank caving. Monitor site.

View looking downslope at potential erosion on the waterside slope (Spring 2019).

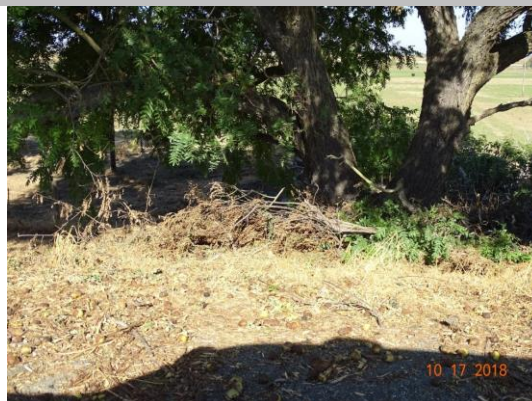
Photo 1 of 1 : FA_2019_RD0003_25_56_20190826_00039.jpg

LM Start	5.03	Rating **	M	Issue No.	56
LM End	5.03	Issue Type +	Ma	Location *	LS
Category	Earthen Levee			GPS Latitude/Longitude	
				Start	End
Item	Encroachments			38.189227 °	38.189227 °
				-121.579983 °	-121.579983 °
DWR ID	DWR_RD0003_02_f_2018_56				
Comment Code					
TR : Tree or limb					
Inspector Comment					
Remove tree limbs on landside slope.

View of tree limbs on the landside slope (October 2018).

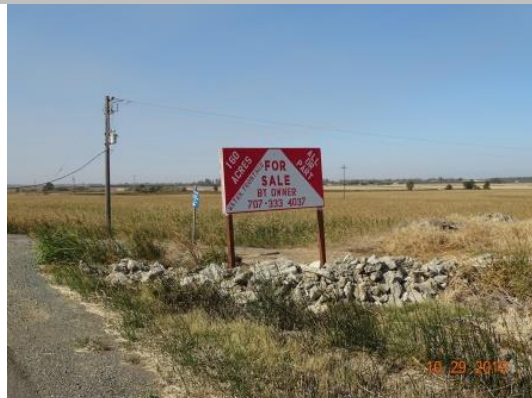
Photo 1 of 1 : FA_2019_RD0003_25_76_20191030_00347.jpg

LM Start	5.35	Rating **	M	Issue No.	76
LM End	5.35	Issue Type +	En	Location *	LS
Category	Earthen Levee			GPS Latitude/Longitude	
				Start	End
Item	Encroachments			38.191392 °	38.191392 °
				-121.574832 °	-121.574832 °
DWR ID	DWR_RD0003_02_s_2013_76				
Comment Code					
MA : Material					
Inspector Comment					
There is concrete rubble on the landside slope.

View looking downstream at concrete rubble on the landside shoulder (Fall 2019).

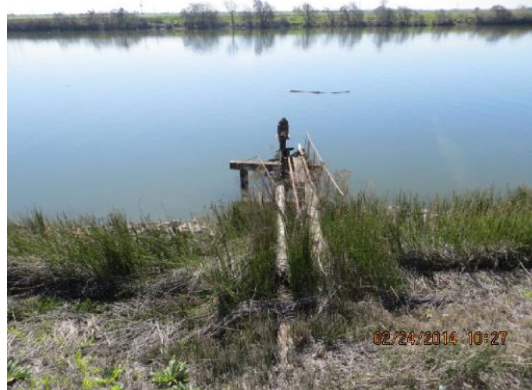
Photo 2 of 3 : UCIP_FA_2019_41643_56792.jpg

Comment Code						
Inspector Comment						
DS_ID:22231 FS_ID:41643 EP_NO: 1311 Repair Type: Non-Urgent Crossing Status: Found UCIP Comments: Appears abandoned and if so should be done so properly. Walkway and pier falling apart. FIELD_STRUCT_DESC: 12-inch steel irrigation discharge pipe through the levee, invert elevation 7.8 feet below the crown. Pump on a pile structure in the river. 42-inch concrete standpipe and a meter pole at the landside (LS) toe. The 12-inch pipe appears to be sleeved with a 10-inch pipe, as it measures 10 inches on both slopes. 1.5-inch electrical conduit through the levee at the same location. (Plans for installing three pipes through the levee authorized under Permit No. 1311, 1948 - Joe Lopes). [Additional Reference(s): DWR Levee Log, 1993. USACE Sacramento O&M Manual 104, February 1960, (RM 20.37)]. FS Date: 2/24/2014

Pump on pier at WS toe.

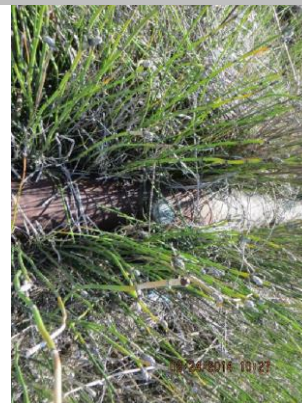
Photo 3 of 3 : UCIP_FA_2019_41643_56791.jpg

Siphon breaker on WS shoulder.

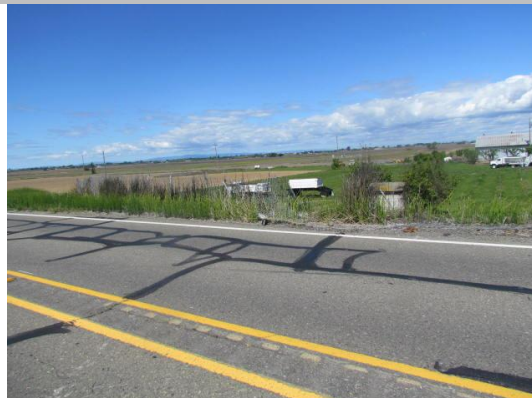
Photo 1 of 1 : FA_2019_RD0003_25_21_20190826_00021.jpg

LM Start	5.53	Rating **	M	Issue No.	21
LM End	5.56	Issue Type +	En	Location *	LS
Category	Earthen Levee			GPS Latitude/Longitude	
				Start	End
Item	Encroachments			38.192358 °	38.192458 °
				-121.571742 °	-121.571320 °
DWR ID	DWR_RD0003_02_s_2012_21				
Comment Code					
FE : Fence					
Inspector Comment					
There is a fence on the landside shoulder.

Looking west at cyclone fence on landward shoulder.

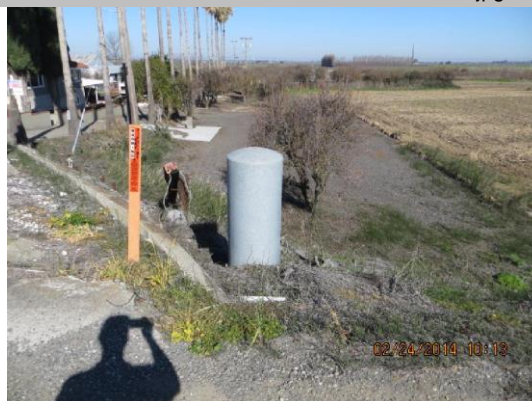
Photo 1 of 3 : UCIP_FA_2019_40542_56797.jpg

LM Start	5.59	Rating **	M	Issue No.	963
LM End	5.59	Issue Type +	En	Location *	
Category	Supplemental			GPS Latitude/Longitude	
				Start	End
Item	DRAFT DWR UCIP Field Study			38.192581 °	38.192581 °
				-121.570807 °	-121.570807 °
DWR ID	22233				
Comment Code					
Inspector Comment					
DS_ID:22233					
FS_ID:40542					
EP_NO: 1311					
Repair Type: Non-Urgent					
Crossing Status: Found					
UCIP Comments: Systed appears abandoned and if so, should be done so properly.					
FIELD_STRUCT_DESC: 2-inch galvanized iron domestic water line through the levee, 4 feet below the crown. Hand pump and pump on the waterside (WS) slope. Tank on the landside (LS) shoulder. (Plans for installing three pipes through the levee authorized under Permit No. 1311, 1948 - Joe Lopes). [Additional Reference(s): DWR Levee Log, 1993].					
FS Date: 2/24/2014

Tank on LS shoulder.

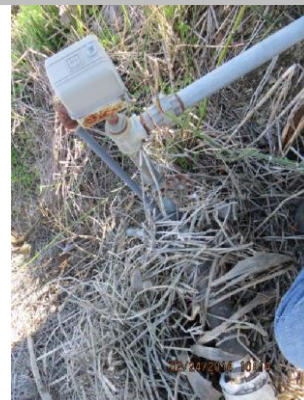
Photo 2 of 3 : UCIP_FA_2019_40542_56796.jpg

Valve next to tank on LS shoulder.

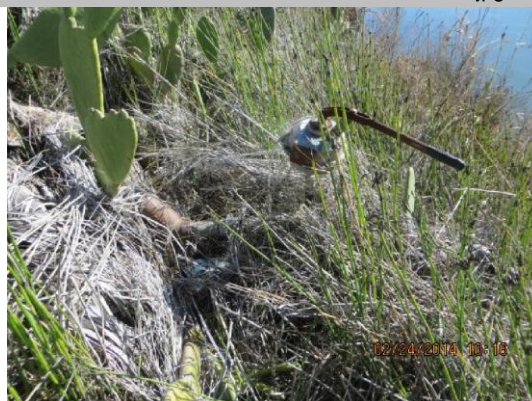
Photo 3 of 3 : UCIP_FA_2019_40542_56795.jpg

LM Start	5.59	Rating **	M	Issue No.	963 (cont)	
LM End	5.59	Issue Type +	En	Location *		
Category	Supplemental			GPS Latitude/Longitude		
				Start	End	
Item	DRAFT DWR UCIP Field Study			38.192581 °	38.192581 °	
				-121.570807 °	-121.570807 °	
DWR ID	22233					
Comment Code						
Inspector Comment						
DS_ID:22233						
FS_ID:40542						
EP_NO: 1311						
Repair Type: Non-Urgent						
Crossing Status: Found						
UCIP Comments: Systed appears abandoned and if so, should be done so properly.						
FIELD_STRUCT_DESC: 2-inch galvanized iron domestic water line through the levee, 4 feet below the crown. Hand pump and pump on the waterside (WS) slope. Tank on the landside (LS) shoulder. (Plans for installing three pipes through the levee authorized under Permit No. 1311, 1948 - Joe Lopes). [Additional Reference(s): DWR Levee Log, 1993].						
FS Date: 2/24/2014

Hand pump and electric pump on WS slope.

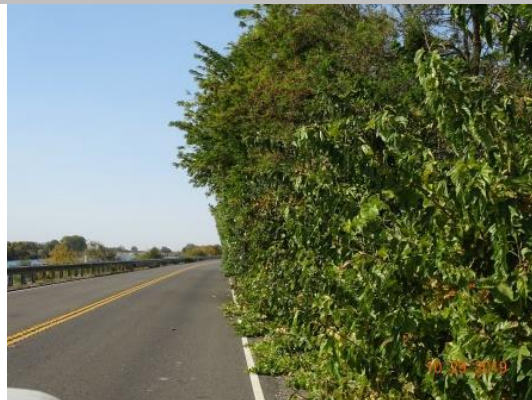
Photo 1 of 1 : FA_2019_RD0003_25_11_20191030_00346.jpg

LM Start	5.81	Rating **	U	Issue No.	11
LM End	5.86	Issue Type +	En	Location *	LS
Category	Earthen Levee			GPS Latitude/Longitude	
				Start	End
Item	Vegetation			38.193552 °	38.193832 °
				-121.566933 °	-121.565995 °
DWR ID	DWR_RD0003_02_s_2012_11				
Comment Code					
V6 : Landscaping					
Inspector Comment

View looking downstream at landscaping on the landside slope (Fall 2019).

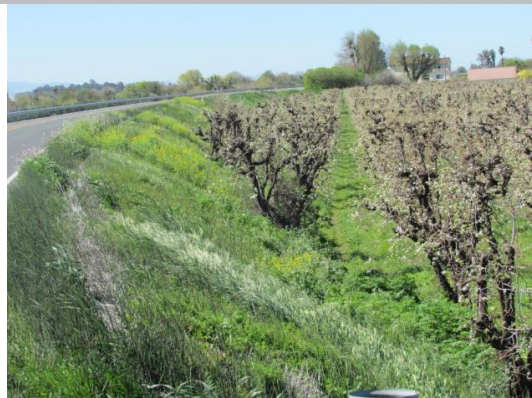
Photo 1 of 1 : FA_2019_RD0003_25_54_20190826_00037.jpg

LM Start	5.98	Rating **	M	Issue No.	54
LM End	6.08	Issue Type +	En	Location *	LS
Category	Earthen Levee			GPS Latitude/Longitude	
				Start	End
Item	Encroachments			38.194705 °	38.195586 °
				-121.564116 °	-121.562669 °
DWR ID	DWR_RD0003_02_s_2012_54				
Comment Code					
CR : Crops					
Inspector Comment					
There is an orchard on the lower levee slope.

Looking south at trees on landward toe.

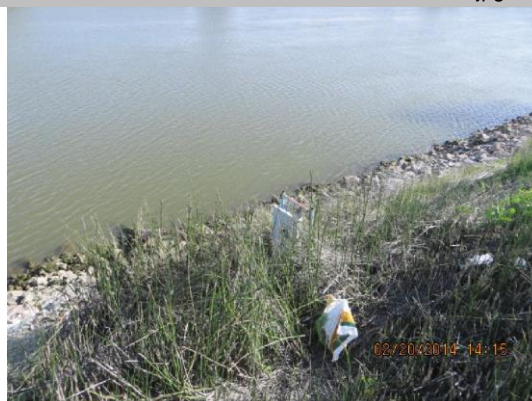
Photo 2 of 3 : UCIP_FA_2019_30672_56445.jpg

Pump in vegetation on WS slope.

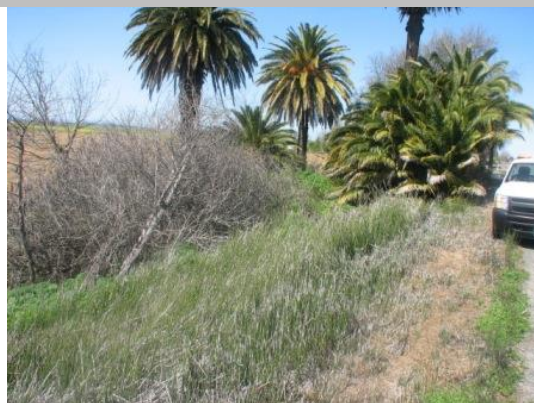
Photo 1 of 3 : FA_2019_RD0003_25_12_20190826_00012.jpg

LM Start	6.88	Rating **	U	Issue No.	12
LM End	6.90	Issue Type +	En	Location *	LS
Category	Earthen Levee			GPS Latitude/Longitude	
				Start	End
Item	Vegetation			38.206363 °	38.206598 °
				-121.558520 °	-121.558530 °
DWR ID	DWR_RD0003_02_s_2012_12				
Comment Code					
V6 : Landscaping					
Inspector Comment					
There are palm trees on the landside slope.

Dense trees at landside toe and shoulder.

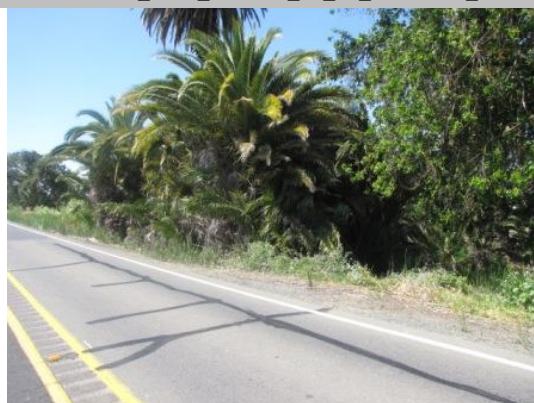
Photo 2 of 3 : FA_2019_RD0003_25_12_20190826_00013.jpg

Looking southwest at dense veg. on landside slope.

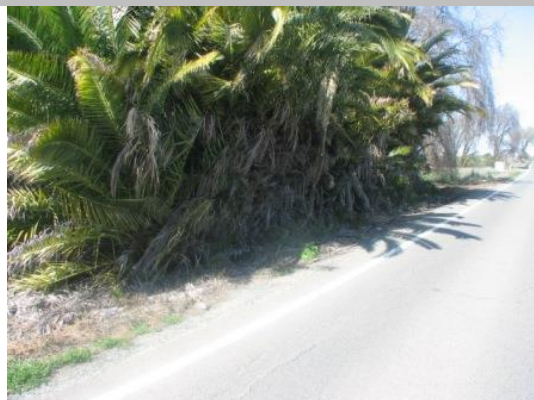
Photo 3 of 3 : FA_2019_RD0003_25_12_20190826_00014.jpg

Front view of palm trees on landside shoulder.

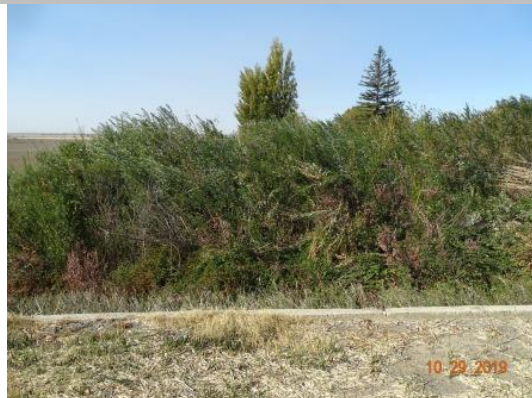
Photo 1 of 1 : FA_2019_RD0003_25_16_20191030_00344.jpg

LM Start	7.01	Rating **	U	Issue No.	16
LM End	7.01	Issue Type +	Ma	Location *	LS
Category	Earthen Levee			GPS Latitude/Longitude	
				Start	End
Item	Vegetation			38.208205 °	38.208205 °
				-121.558565 °	-121.558565 °
DWR ID	DWR_RD0003_02_s_2012_16				
Comment Code					
V2 : Remove the wild growth other than native grasses from the levee slopes.					
Inspector Comment

View of thick vegetation at the landside toe (Fall 2019).

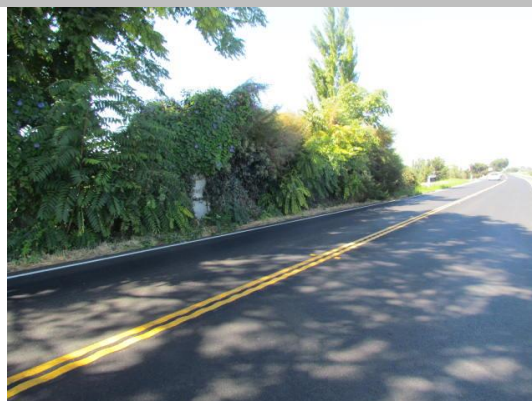
Photo 1 of 1 : FA_2019_RD0003_25_55_20190826_00038.jpg

LM Start	7.22	Rating **	U	Issue No.	55
LM End	7.22	Issue Type +	En	Location *	LS
Category	Earthen Levee			GPS Latitude/Longitude	
				Start	End
Item	Vegetation			38.211357 °	38.211357 °
				-121.558468 °	-121.558468 °
DWR ID	DWR_RD0003_02_f_2019_55				
Comment Code					
V6 : Landscaping					
Inspector Comment

Looking northwest at dense landscaping on landward shoulder and slope.

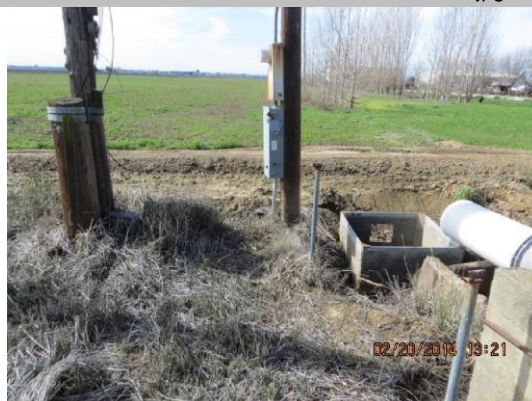
Photo 2 of 3 : UCIP_FA_2019_30648_56413.jpg

Meter on pole next to concrete distribution box on LS toe.
